Upper Hunter Country Rail Trail

TRAIL DEVELOPMENT PLAN

Upper Hunter Country Rail Trail Feasibility Study

December 2016

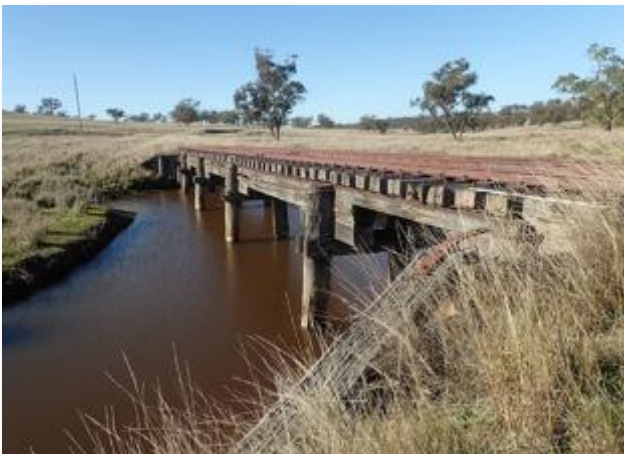
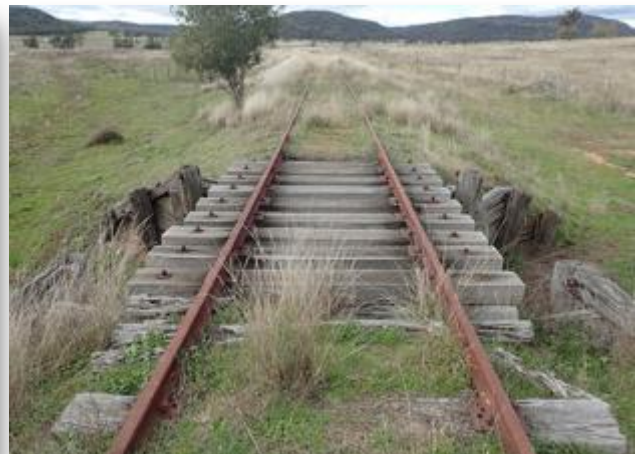
Repairing bridge abutments and installing decking and handrails will be essential tasks in making safe the numerous bridges along the proposed rail trail between Merriwa and Sandy Hollow.

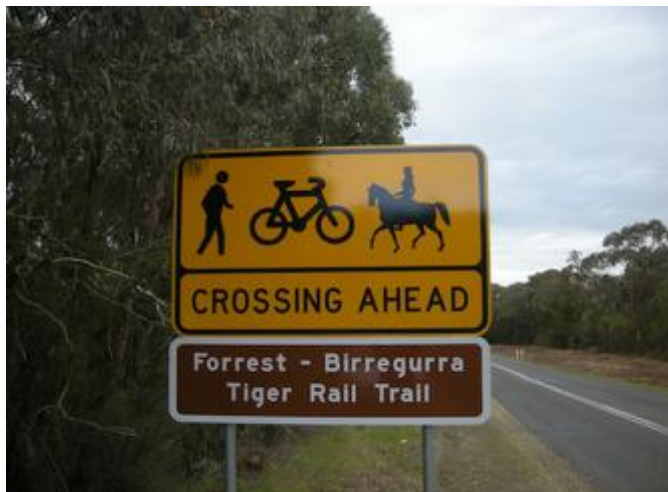
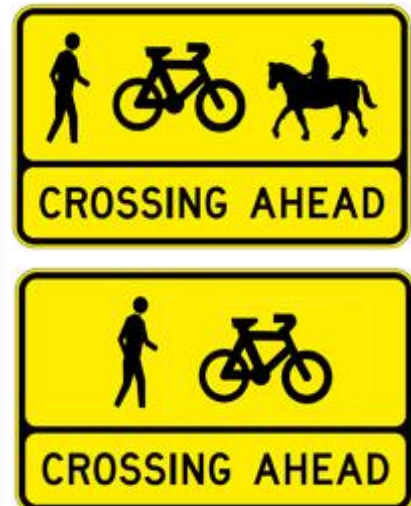
Above: Signage for the Tiger Rail Trail in Victoria warns of the upcoming road crossing as well as promoting its existence to road users. Right: different signs may need to be used, depending on trail user groups being permitted on the proposed trail.

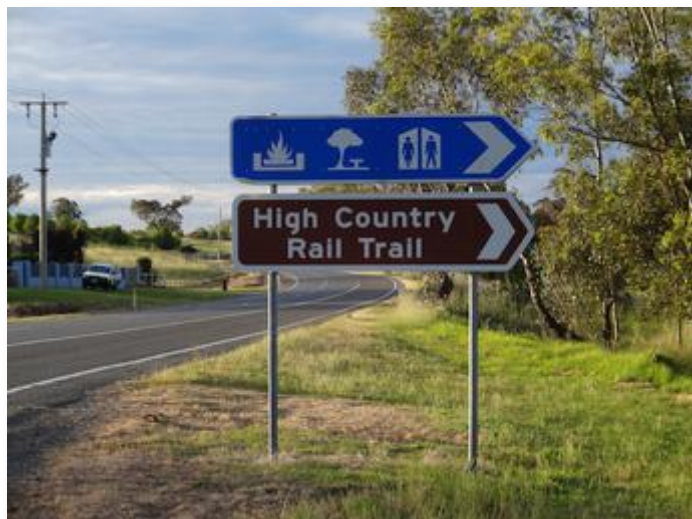
Signs pointing in to the "Trailhead", as used on the High Country Rail Trail in Victoria, are an excellent means of directing trail users to a Trailhead and serve to promote the existence of the rail trail to passing motorists, tourists and local people.

and visitors become more aware of the trail (a good example is the High Country Rail Trail). The trailhead drawings in Appendix 2 indicate the placement of these types of signs on the major roads near to the trailhead.

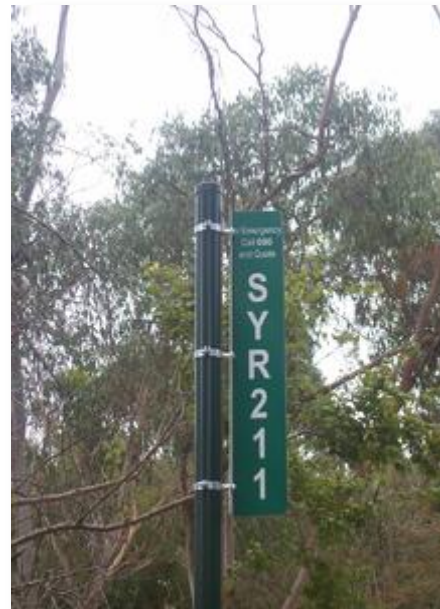
An Emergency Marker sign on the Lilydale Warburton Rail Trail in Victoria.

It is strongly recommended that “Emergency Markers” be installed along the Upper Hunter Country Rail Trail.

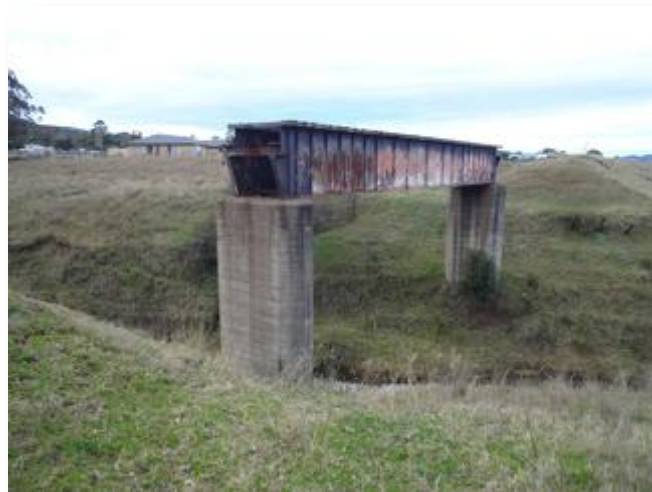
The original Halls Creek bridge used timber beam approach spans and the connections for these timber beams remain on the ends of the steel girder main span. There appears to be no reason why the brackets on the ends of the main girder cannot be reused for new approach spans, either steel or timber. Two concept designs for the re-use of the Halls Creek bridge have been prepared using steel trusses (see Appendix 4). The parallel chord alternative would be simpler to fabricate but would be heavier. The alternative with a convex bottom chord would be slightly lighter and may be considered more aesthetically pleasing. Both alternatives have the potential of being fabricated and treated off site and being lifted into place as a whole.

Halls Creek Bridge near Sandy Hollow.

The deck structure, including the barriers, could be fabricated and fitted separately or included in the single crane lift if a suitable crane was available. The erection procedure should form part of the final design.

In terms of decking, steel frames and grating (such as FRP) is a suitable option. The only reported problem is that dogs have to be kept off as their droppings are difficult to clean up. The report recommends (see Section 7.1) that dogs not be allowed on

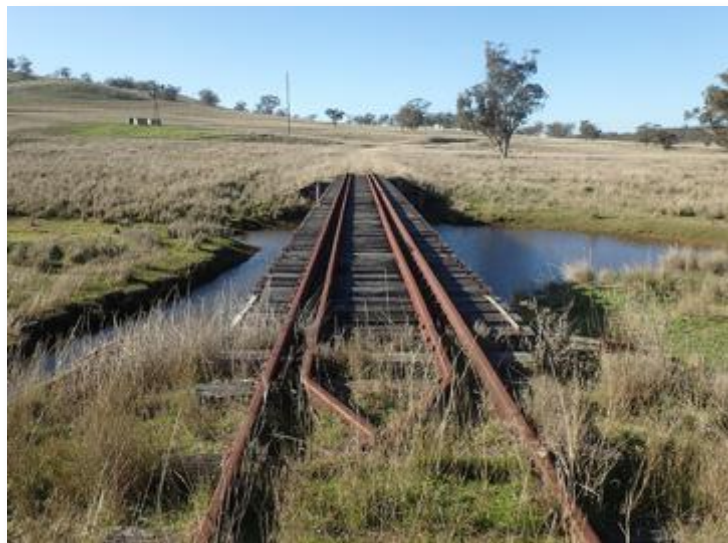
To ensure re-use of the 32 metre timber trestle bridge at Wappinguy Siding, it is critical that the steel rails and sleepers be retained to provide structural integrity to the bridge (by cutting the steel track several metres away from the bridge abutment at both ends). The sleepers and steel track will help tie the entire structure together, thereby resulting in a more rigid, stronger and longer lasting structure. With the sleepers left in place, timber bearers are fixed to them to provide a 'clean' surface to attach decking and handrails. Decking should be attached perpendicular to the direction of travel (an alternative attachment is at 45 degrees to the bearers – the attachment recommended by the Rails to Trails Conservancy). Decking timbers should never be fixed parallel to the direction of travel.

The bridge near Wappinguy Siding.

Timber decking (or a recycled plastic such as Enduroplank, a recycled wood plastic composite product such as Evertuff) can be installed over the top of the retained steel track. A grating system (similar to that which is proposed for Halls Creek bridge) would only be suitable for this bridge if horses are not to be allowed on the trail.

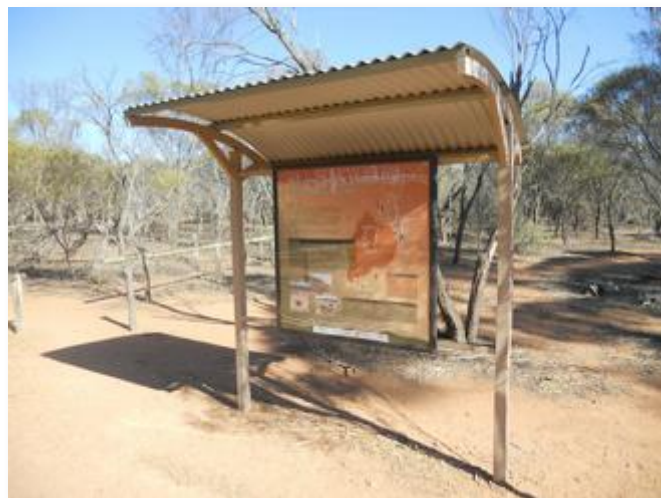
A typical trailhead interpretive shelter. Usually these shelters may contain two information panels (front and back, incorporating general information, a map with the trail route and key features and important safety information for trail users.

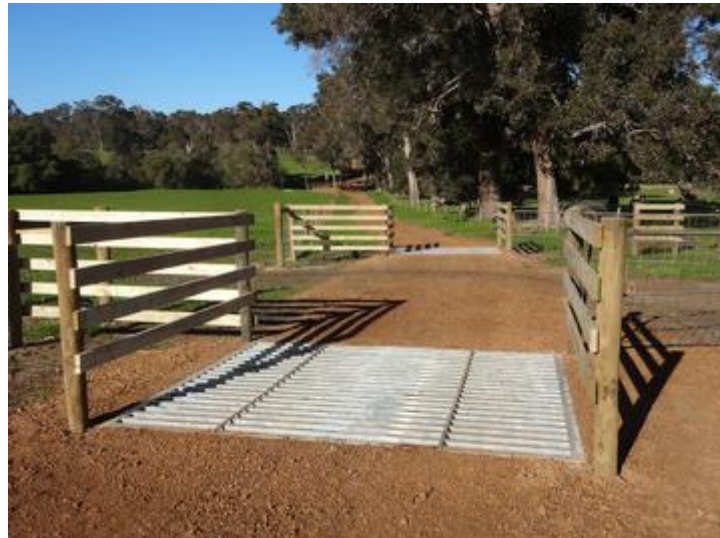
Stock grids along rail trails, such as this one on the newly opened extension of the rail trail south of Margaret River in WA, can allow stock crossings to be open 24/7 thereby enabling stock and machinery to cross the trail unimpeded.

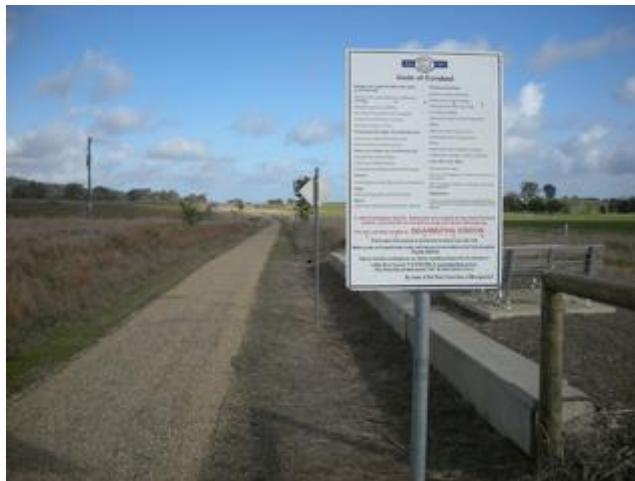
The Murray to the Mountains Rail Trail has a Code of Conduct sign board at regular intervals along the trail ensuring that all trail users are aware of their rights and responsibilities.

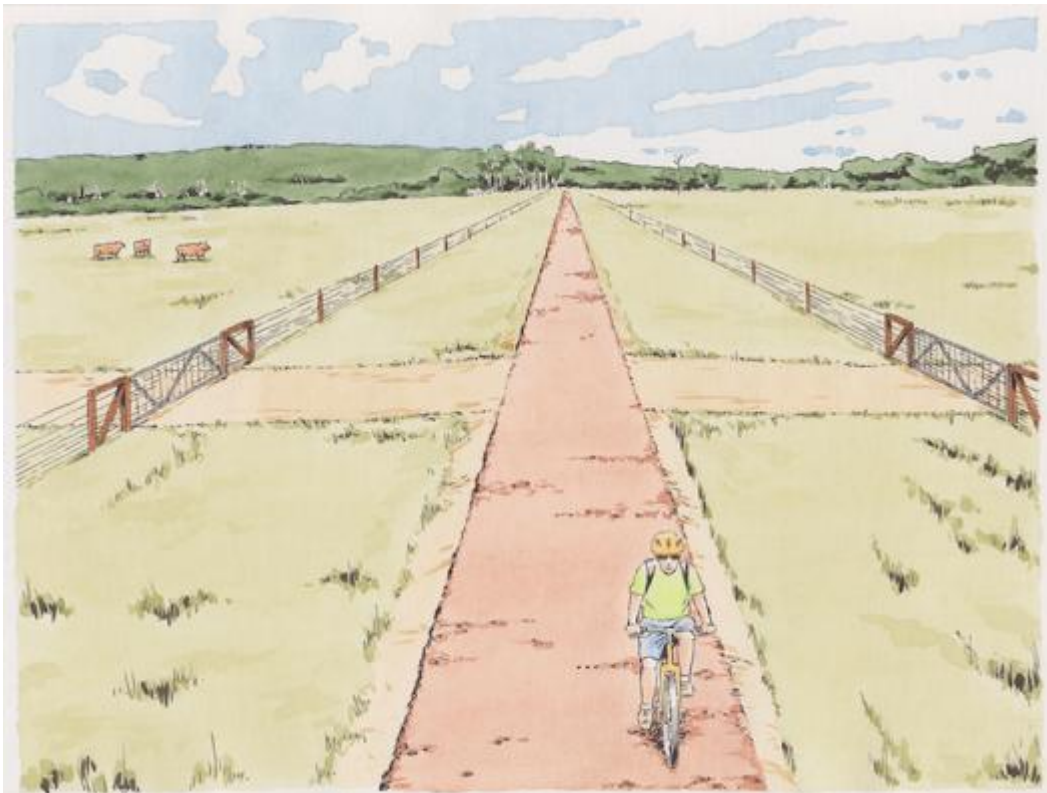
*Above: Stock Crossing Type A: crossing open 24/7 for stock and machinery.
Below: Stock Crossing Type B: Trail open 24/7. Gates in side fences.*

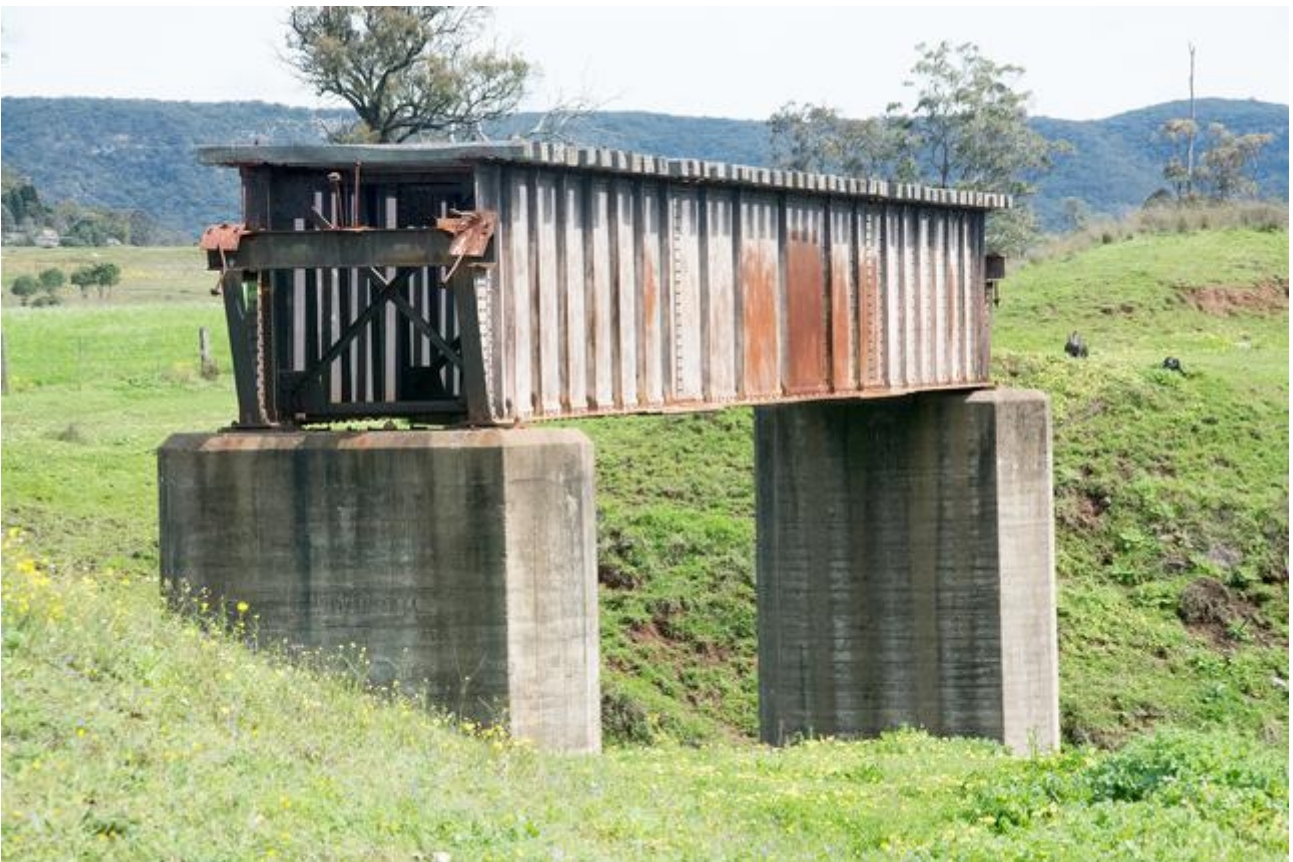
HALLS CREEK BRIDGE, SANDY HOLLOW

PROPOSED RAIL TRAIL, MERRIWA TO SANDY HOLLOW

DESIGN STUDY FOR MIKE HALLIBURTON ASSOCIATES RECREATION TRAIL PLANNERS

The rail corridor between Merriwa and Sandy Hollow has a number of bridges. The two major bridges are the concrete and steel bridge at Sandy Hollow (over Halls Creek) and a smaller (36m) timber bridge immediately south of where Wappinguy Station stood. There are a number of other smaller bridges across ephemeral creek lines. Modification to the bridges is essential for their conversion into a condition where trail users can travel across them. In many cases replacement is a better option.

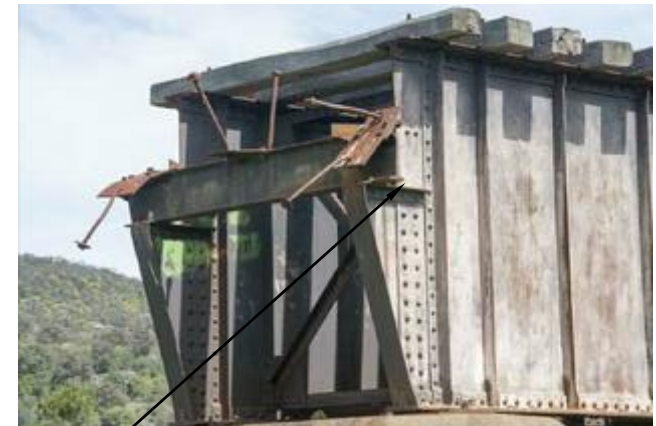
Drawing Z005 - Sk.1A of concept design

Steel truss option 1

New concrete abutment on bored or driven piles depending on geotechnical recommendations. Sliding bearing at abutment ends.

Deck with attached railings on approach and main (existing girder) spans

Steel truss option 2

Attach to existing girder bracket.
Alt. bottom bearing to existing pier
