**PROJECT NUMBER – E04-0619**  
**JUNE 2019**

**SCONE WASTE  
FACILITY  
NOBLET ROAD  
SCONE NSW**

**Project Name** – Groundwater Monitoring – Scone Waste Facility –Quarterly Monitoring Round

**Client** - Upper Hunter Shire Council

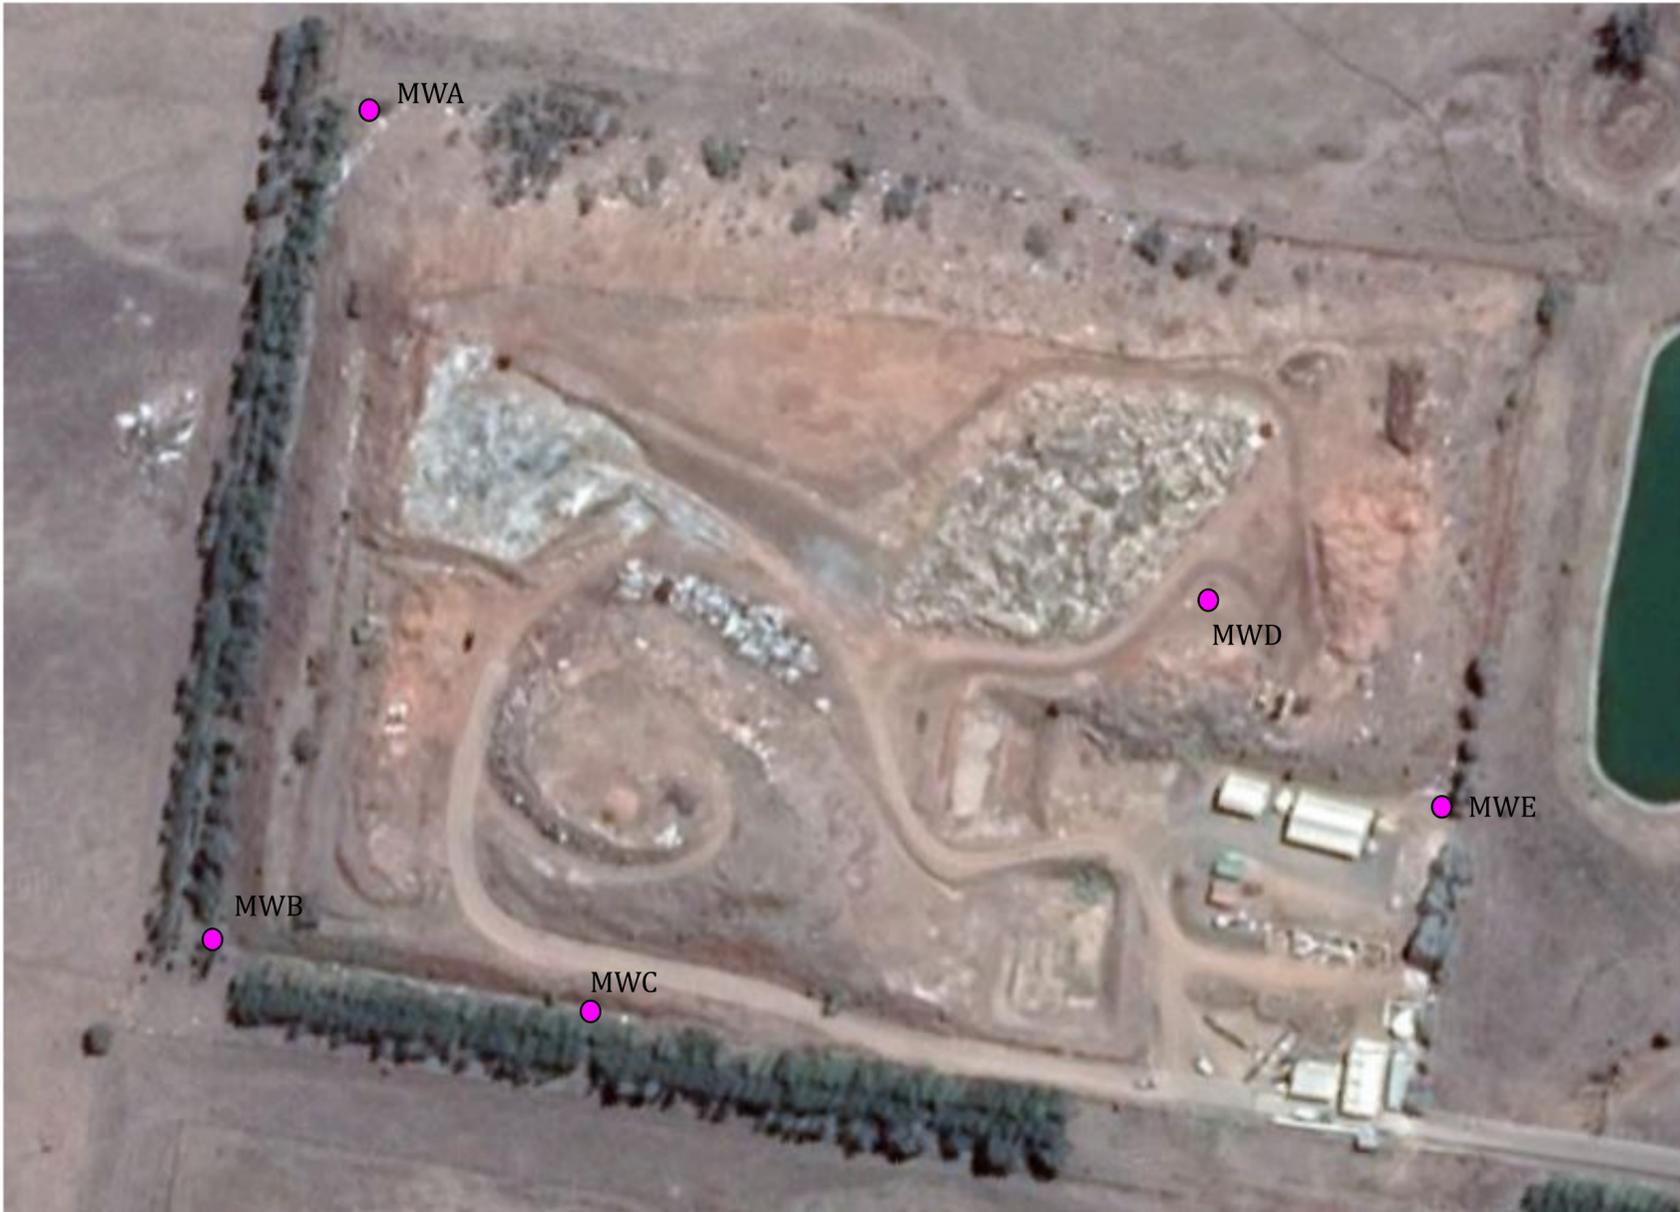
**FIGURE 1**  
**SITE LAYOUT AND**  
**SAMPLING LOCATIONS**

The inferred hydraulic gradient for the site is a down gradient towards Parsons Gully to the west. The location of the four wells surrounding the landfill place wells MWA, MWB and MWC down-hydraulic gradient and well MWE up-hydraulic gradient of the landfill. Well MWD is located within the perched landfill water table, this enables access to the leachate within the landfill.

● Monitoring Well Location
