**PROJECT NUMBER – E04-1222  
DECEMBER 2022**

**QUARTERLY  
GROUNDWATER  
MONITORING**

**SCONE WASTE  
FACILITY  
NOBLET ROAD  
SCONE NSW**

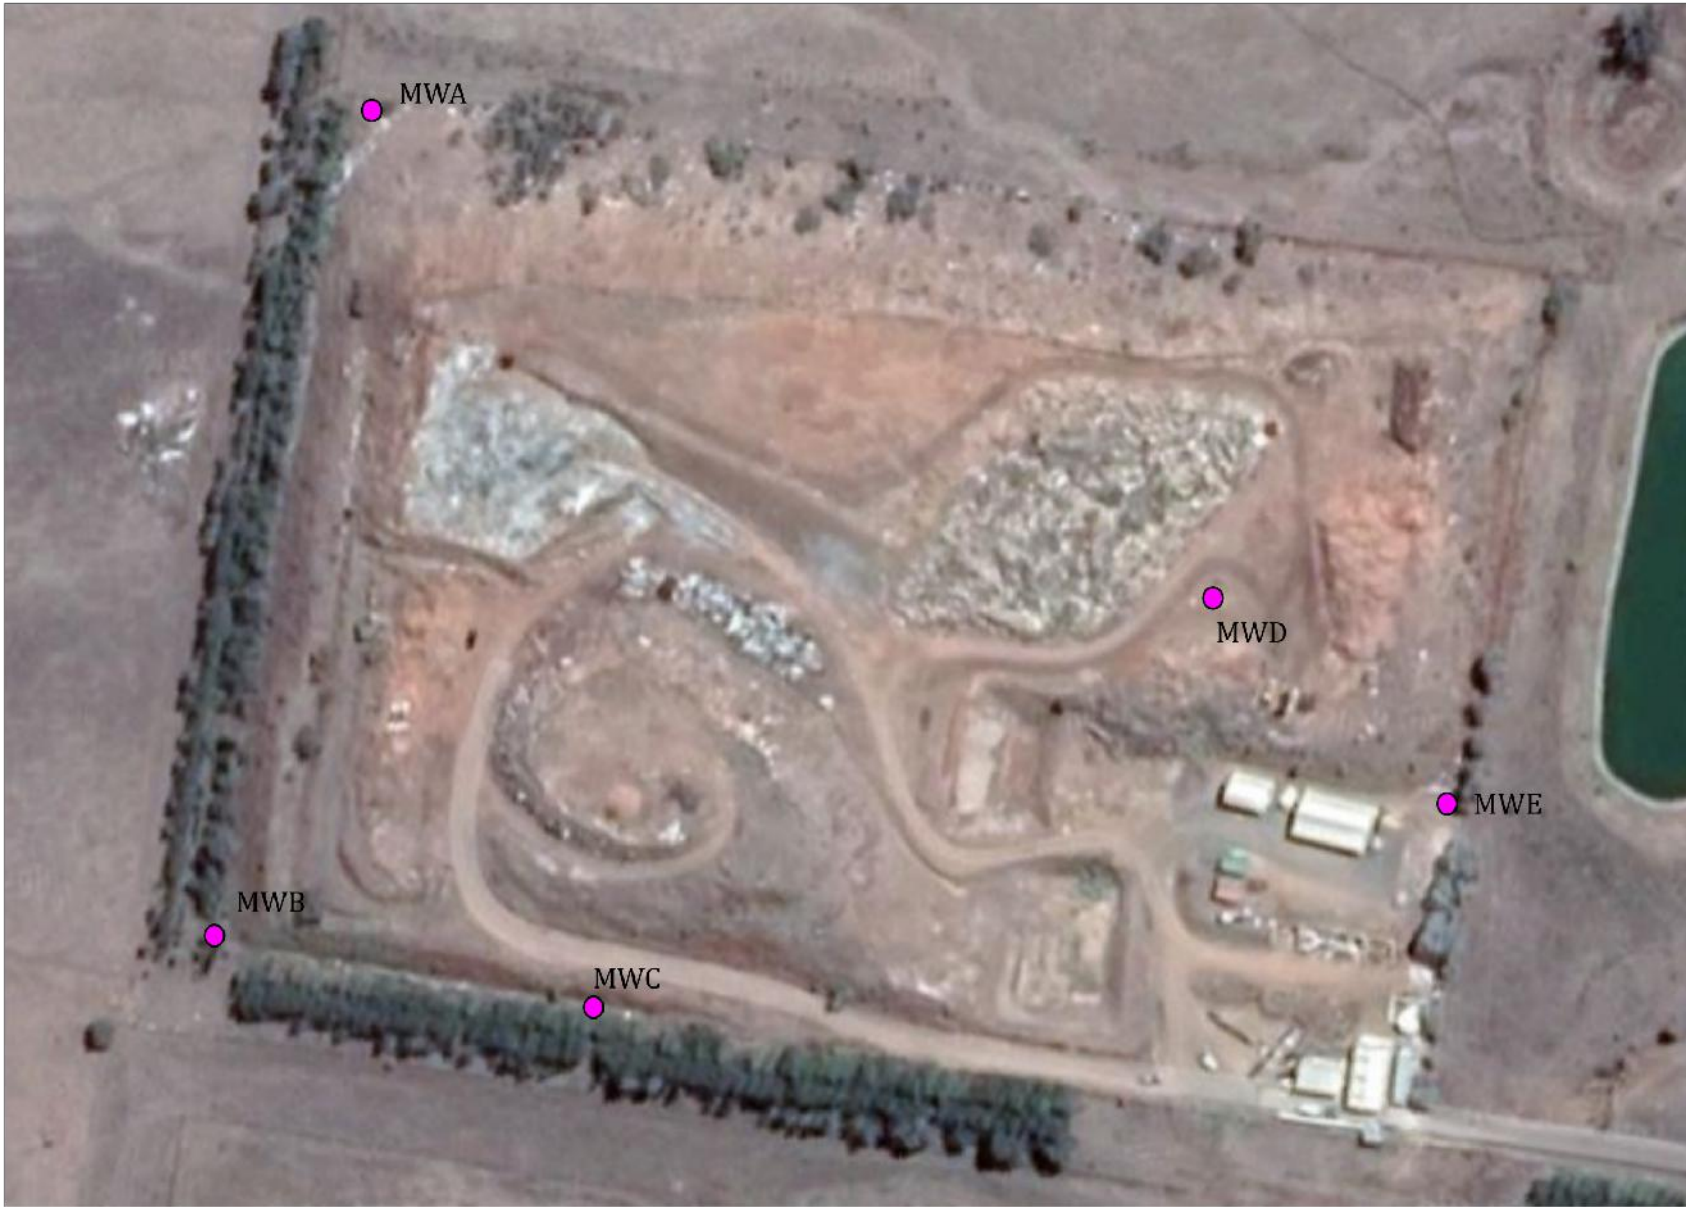
**FIGURE**

**Figure 1**                      Site layout with sample locations

● Monitoring Well Location

Refer to **Figure 1: Site Layout with Sample Locations**

The inferred hydraulic gradient for the site is a down gradient towards Parsons Gully to the west. The location of the four wells surrounding the landfill place wells MWA, MWB and MWC down-hydraulic gradient and well MWE up-hydraulic gradient of the landfill. Well MWD is located within the perched landfill water table, this enables access to the leachate within the landfill.
