Gummun Place Hostel

Presentation to Community
Consultation session on behalf of
Upper Hunter Shire Council

7 May 2025 / Version 1.0

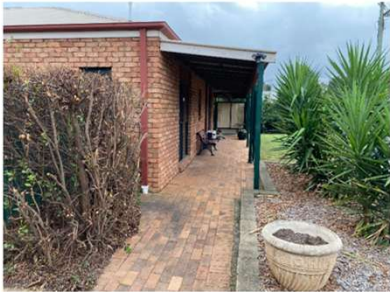
1. Backyard is substantial. Staff are unsure where border sits between aged care and council land. No fences, which creates a risk of ingress by external persons and the ability for residents to wander off in multiple directions.

2. Only structures in back backyard are one open and one closed shed.

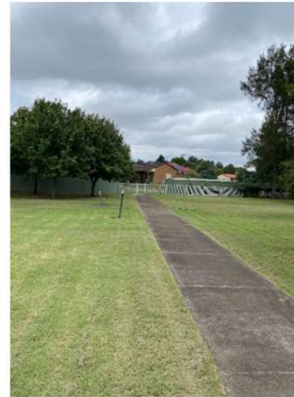
3. Walkway to neighbouring independent living units is closed at the fence line, making this redundant.

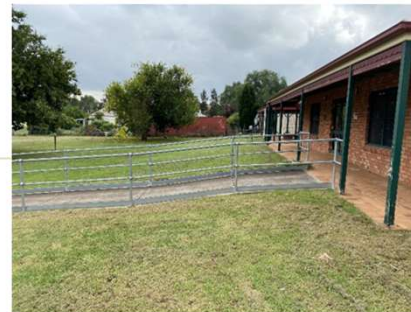
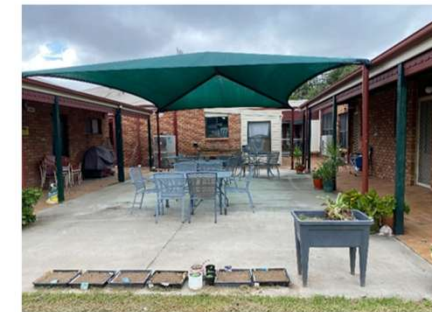
4. The back of the property is not flat, lacks railings, has limited seating for residents to rest as they walk along and has been the cause of multiple falls and trips. Some pavers are raised/damaged. Areas are not suitable for higher-care needs residents.

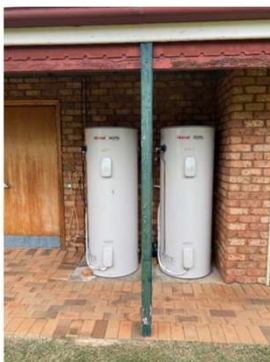
5. Water tanks. There are two like this on each wing of the building (four in total). The volume of water in the tanks seems appropriate for 16 residents. Rooms close to these get hot water in a timely manner. Rooms at the other end of each wing take a long time to get hot water as it goes through the roof and under the floor, including exposed areas that ice over in winter.

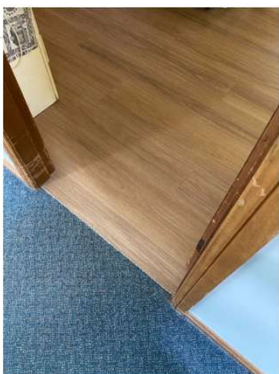
6. This lino floor type is not suitable for wet areas in aged care, but has been installed in rooms that have had recent renovations. The lino comes in slats to look like floor tiles, which allows water to get between the slats and cause them to swell and rise (becoming trip hazards) or stay damp (causing mould hazards). Best practice in aged care is single-piece lino floor covering, with the option to cover the sides up the walls if residents or staff are urinating on the walls.

Topic	Issue	Implication for Council
Operational Efficiency	Site comprises too few beds to generate a surplus under current government funding regime.	Capital Investment: More beds would be required to increased capacity to at least 60 beds to generate sustainable margins
Workforce Composition	Half of current roster shifts are filled by agency staff. Proportion of local staff can be expected to fall in future.	Workforce: There are not enough local workers to support current number of residents. Peer organisations are targeting recruitment of overseas workers and constructing low-cost staff housing options to attract staff. This constraint becomes even more important if the facility size is increased.
Internal Flooring	Rooms with carpets are no longer responding to deep cleaning. Rooms with retail grade linoleum slats are unsuitable for wet areas as they become trip hazards or harbour mould.	Capital Costs: Safety, amenity and hygiene of rooms will require investment in new flooring.

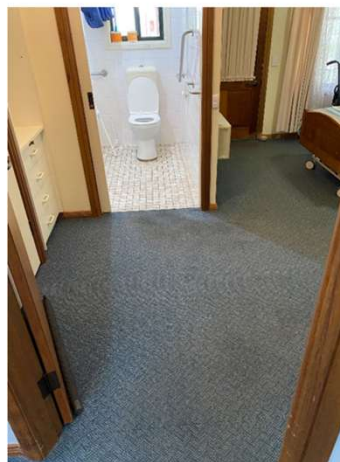
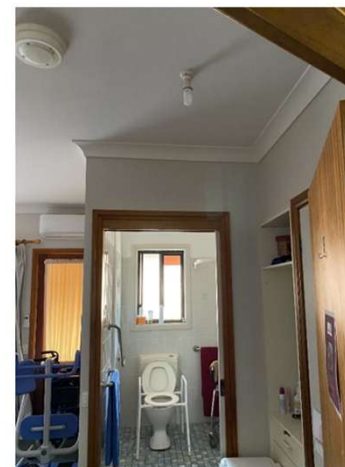
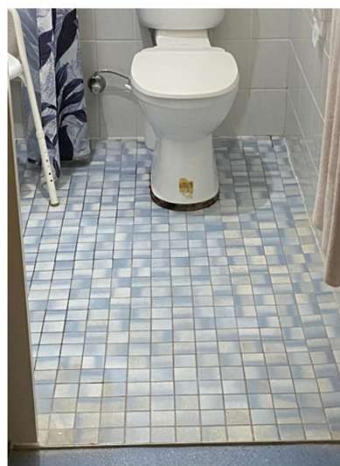
7. Example tiled bathrooms. Two examples were sighted with buckled tiles due to subsidence under the floor (South Wing). The first picture also shows a discoloured and dirty carpet. This would be the worst example of carpet in the facility. Half the rooms have carpet, and spills of bodily fluids and shower water runoff have built up.

Bathrooms	Resident bathrooms are small and do not safely fit two staff members plus resident and their shower chair Floor tiles are uneven in South Wing rooms where slab has warped.	Worksafe and Resident Safety Obligations: Slip and fall events are increasingly likely in short term. A current bariatric (obese) resident is being lifted into shower area in their chair by two staff members, creating a high risk of back injury for staff or resident being dropped on floor. Investment: Build at least one a modern aged care bathroom in one of the staff rooms on site to care for bariatric, frail and palliating residents
External Flooring	Low care hostel design means that outdoor areas are uneven and lack railings and seating	Safety: Residents have already fallen and more falls can be expected on outdoor pathways and garden areas.
Site Security/Access	Site is designed without secure fencing and has multiple points of entry and exit. Residents living with a dementia are an increasing cohort of aged care sector.	Capital Costs: Without fences to control foot traffic through the front reception area, these residents can wander into traffic on main road (50 metres from facility) without staff being aware.

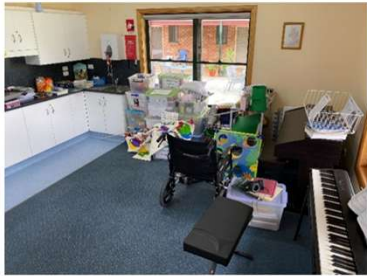
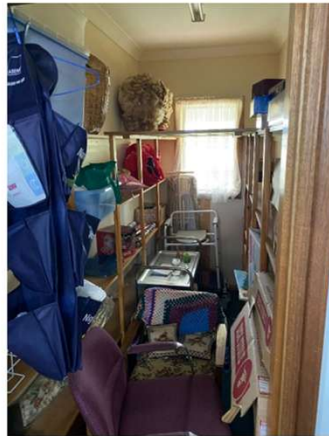
8. Like most older facilities, there is not enough space to store equipment. The image on the left is the lifestyle officer's games, crafts and dress-up materials. The image on the right is one of multiple cupboards. The kitchen is also low on space, as it is a standard residential kitchen layout and does not have enough dry, cold and frozen storage options.

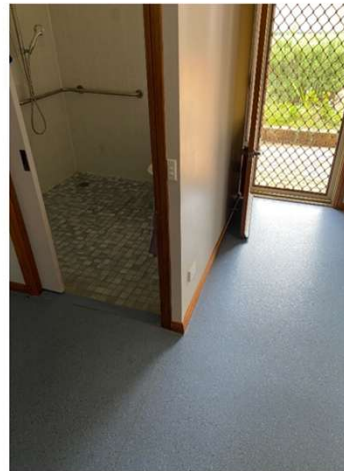
This is the original standard room layout, with non-slip lino for easy cleaning and unrenovated bathroom. There are only two few rooms left like this. All bathrooms in the facility are this size, which is too small to safely accommodate a frail/immobile resident and two staff members. Any showering activity that is conducted onsite with this type of resident is potentially unsafe.

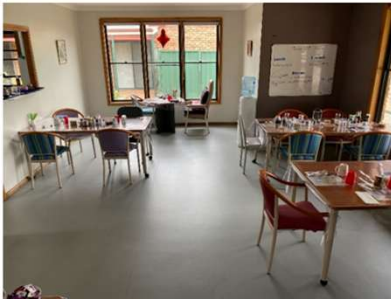
9. Dining room area is a touch small, but serviceable for mobile residents. A concern is the lack of suitable seating for residents with bariatric (obese) and some forms of mobility impairment diagnoses.

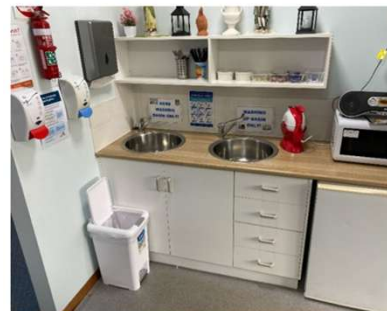
10. Each wing has a single sink and handwash area. This can be sufficient for only 8 residents per wing. The items in the photo are all accessible to residents, which may pose a risk as the number of residents living with an advanced form of dementia has increased.
