**PROJECT NUMBER – E04-0323**  
**MARCH 2023**

**QUARTERLY  
GROUNDWATER  
MONITORING**

**SCONE WASTE  
FACILITY  
NOBLET ROAD  
SCONE NSW**

**Project Name** – Groundwater Monitoring – Scone Waste Facility –Quarterly Monitoring Round

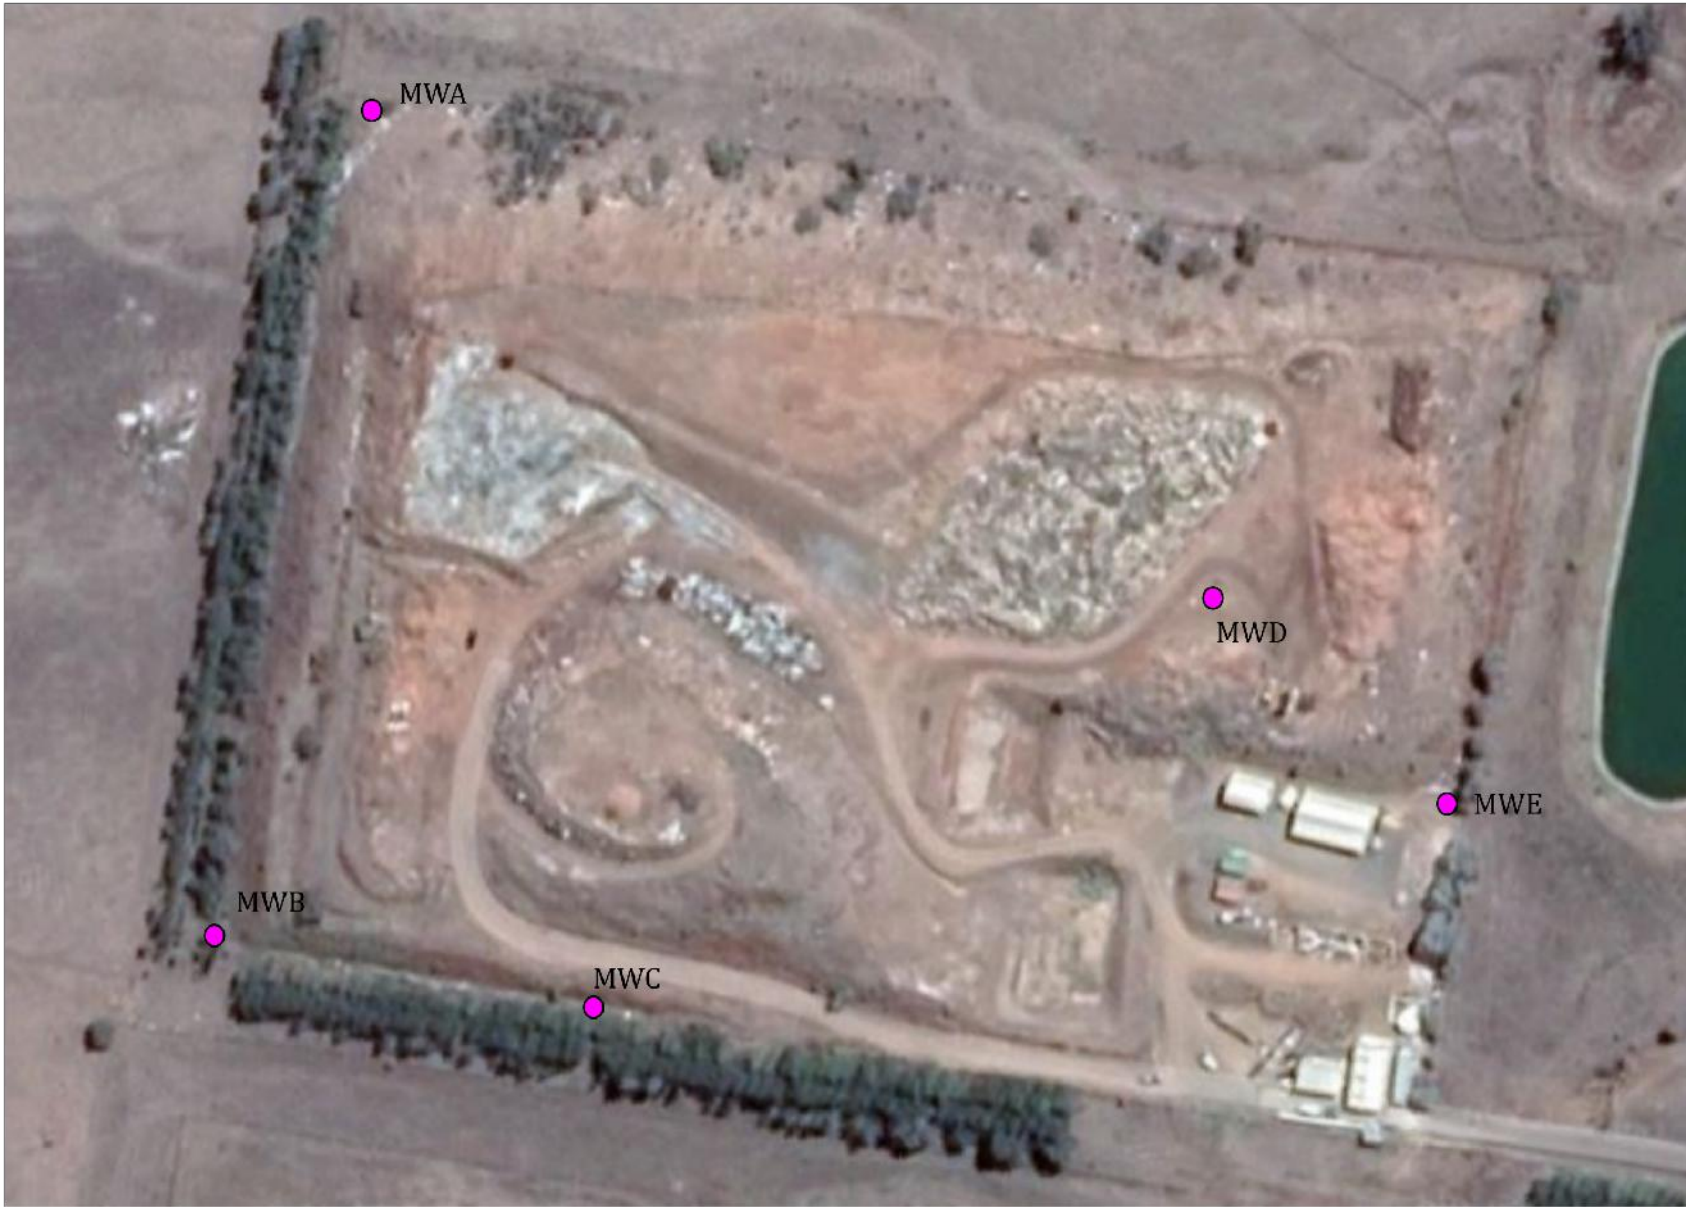
**FIGURE**

Refer to **Figure 1: Site Layout with Sample Locations**

The inferred hydraulic gradient for the site is a down gradient towards Parsons Gully to the west. The location of the four wells surrounding the landfill place wells MWA, MWB and MWC down-hydraulic gradient and well MWE up-hydraulic gradient of the landfill. Well MWD is located within the perched landfill water table, this enables access to the leachate within the landfill.
